12  
TECHNICAL REPORT M-221  
July 1977

EVALUATION OF THE CORROSION RESISTANCE  
OF ALTERNATE REVETMENT WIRE FABRIC  
MATERIALS IN THE LOWER MISSISSIPPI RIVER

by  
E. P. Cox  
C. G. Chen

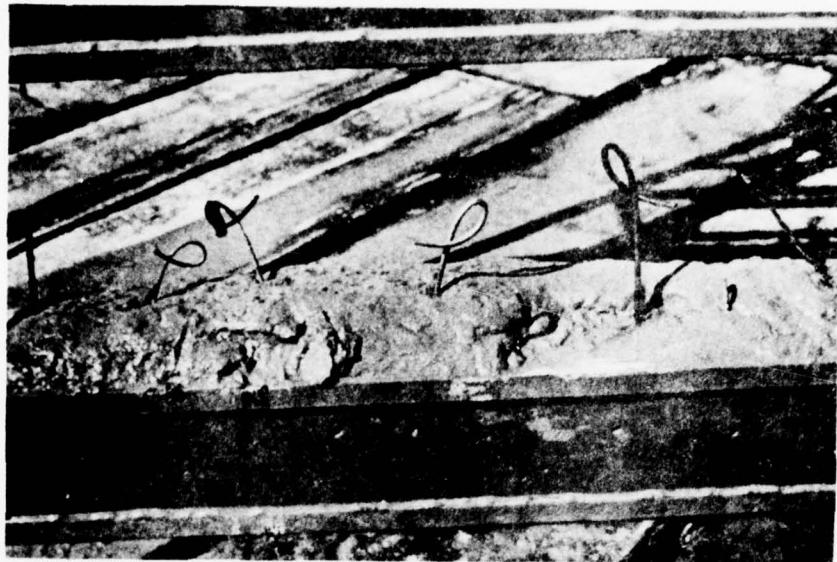
The wire specimens were then cast into 6 in. × 6 in. × 36 in. (152 mm × 152 mm × 0.9 m) concrete blocks. Table 4 gives the composition of the concrete, which was alkaline (pH 12) and may have been somewhat porous, since it was not vibrated during casting. The wires were embedded up to about one-half their length. Wires with looped ends were set so the loop was exposed to the water, as shown in Figure 4.

**Figure 4.** Test block with looped-end test wires after exposure.

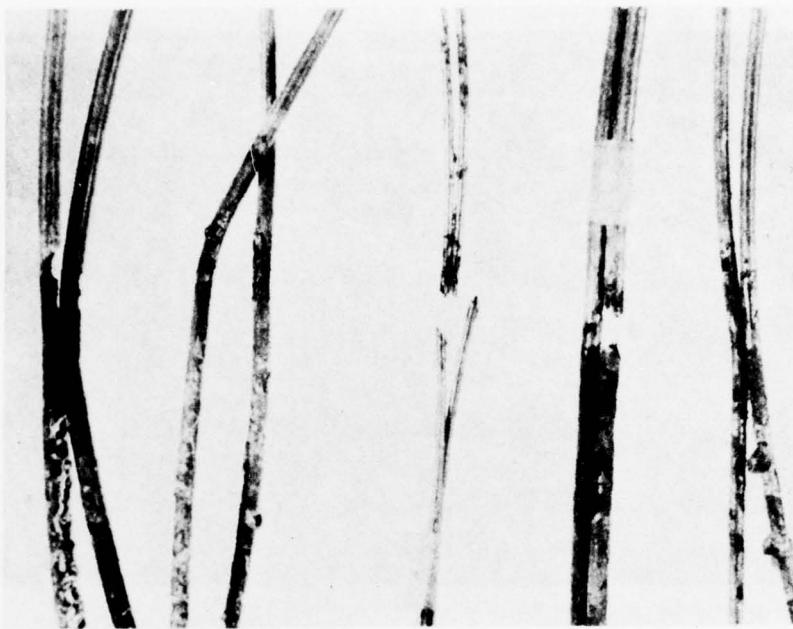
Spot-welded specimens of AISI 201 were also exposed in the Michoud Canal brackish water site. After cleaning, extensive corrosion attack could be seen in the weld region (Figure 6); this corrosion progressed into the interior of the wire. No corrosion attack was seen elsewhere.

Spot-welded specimens of AISI 301 were heavily corroded in the heat-affected zone (just outside the weld region). Close examination of this area revealed that the interior metal was either missing (corroded away) or heavily oxidized. The weld regions were lightly attacked. No corrosion was observed elsewhere.

Spot-welded specimens of Armco 18-2 were completely corroded through in the heat-affected zone (Figure 6) after 15 months of exposure in brackish water. Corrosion extended into the weld, leaving only a hollow wire surrounded by an outer skin of uncorroded material.

Spot-welded specimens of AISI 430 (Figure 6) were completely corroded through after 15 months of exposure to brackish water. The worst corrosion attack occurred in the heat-affected zone just outside the weld. The weld itself was also heavily corroded, and other regions along the length of the wire were corroded and porous.

**Figure 6.** Spot-welded stainless steel wire specimens exposed 15 months in brackish water. From left: AM 363, AISI 201, Armco 18-2, AISI 430, and AISI 301. (Block W-2)

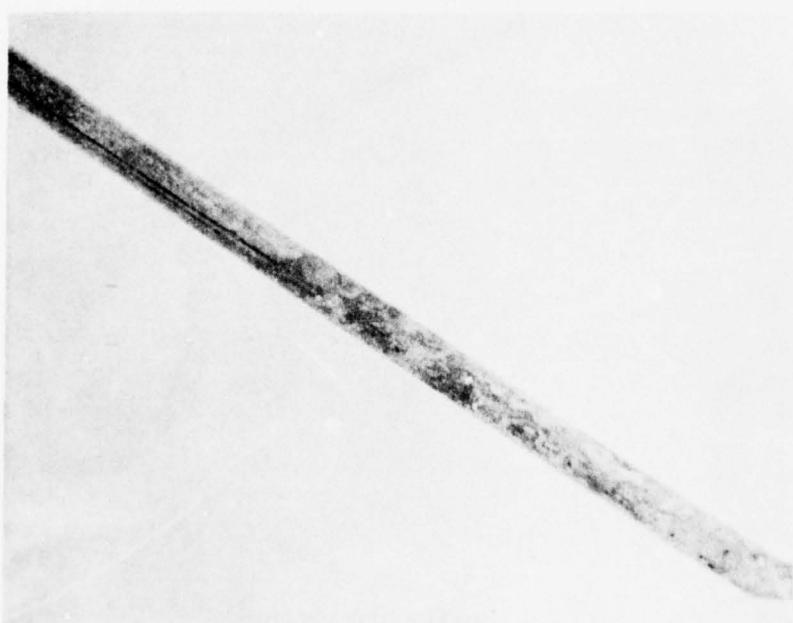
**Figure 9.** Corrosion and pitting in AM 363 stainless steel wire after 15 months of exposure in brackish water. (Block 48)

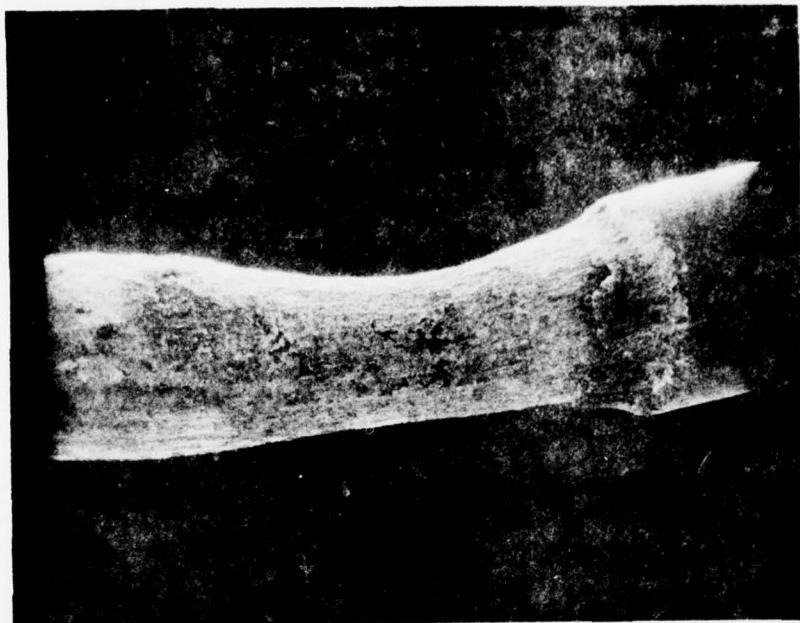
**Figure 11.** SEM photograph of the accelerated corrosion region in plain carbon steel wire. Note the geometry of attack, the layered corrosion region, and the apparent attack at the grain boundaries.

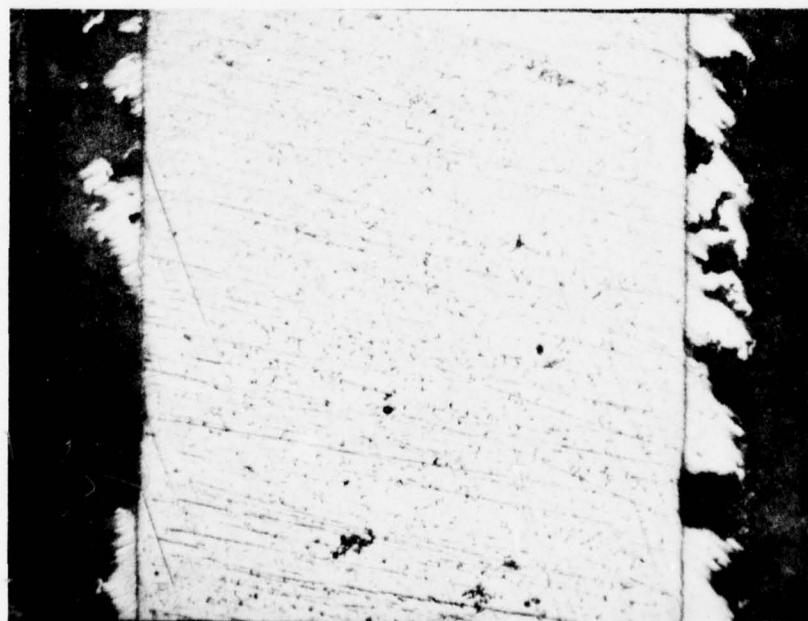
**Figure 12.** Micrograph of galvanized wire after exposure for 1 year. Note the presence of deep pits in the zinc outer layer which penetrate to the surface of the steel. (50x)
